SUBJECT: Site Inspection, U. S. Energy, Velvet Mine, M/037/040, San Juan County, Utah

Date of Inspection: March 19, 2004  
Time of Inspection: About 2:40 to 3:10 p.m.  
Conditions: Mostly clear, 60's  
Participants: Paul Baker, DOGM

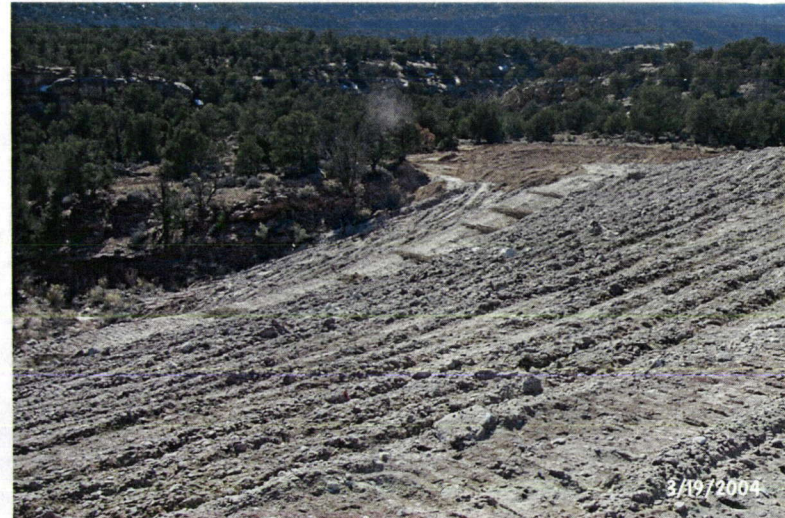
**Photo 4.** Waste pile outslope that did not receive topsoil. Note the lack of erosion.

On the terrace cutting diagonally across Photo 4, one can see dark spots. This is manure, and the picture shows what it looks like over most of the site.
